Manhole Inspection Summary

Manhole # S21W__015MH

Insp Date: **7/2/08 9:24 AM**

Location Address: **1930 maisel st**

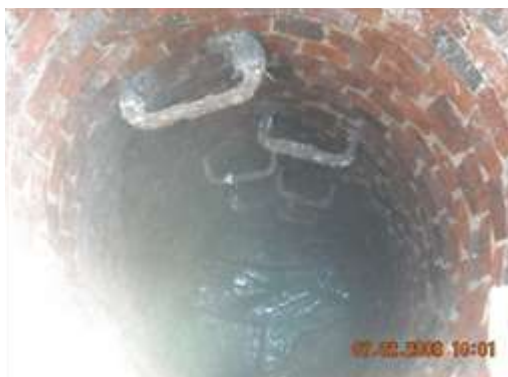
Defect 1

Count: **8** Missing: **0** ☒ **Corroded**

corroded steps

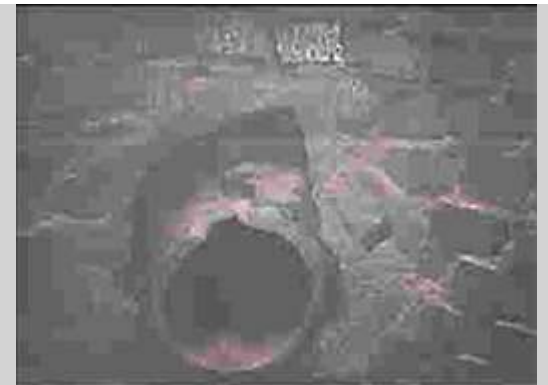
4 O'Clock Inflow

8 in. Circular Gravity Sewer
Pipe In @ 4 OClock

Pipe Height: **8.4** (in.) Rod and Bar (Angled)
Pipe Material: **Clay** ☐ Pipe Lined
Invert Depth: **8.74** (ft.) Flow Characteristics: **Fast**
Deposits: ☒ None ☐ Mud ☐ Sludge ☐ Debris ☐ Grease
Silt Depth: **0** (in.) Deposits Extent:
Infiltration: **Evidence** Pipe Seal Cond: **Broken**
